**Flood Control Project Maintenance
Levee Inspections**

Fall 2018 Levee Maintenance Deficiency Summary Report

Sacramento River Basin

RD0784	Overall LMA Rating	Total LMA Miles						
Reclamation District No. 0784 Plumas Lake	A	33.20						
Rated Item	Maintenance Deficiency				Enforcement		Design & System Obsolescence	
	M Miles	U Miles	M + 4U Miles	Threshold %	M Miles	U Miles	M Miles	U Miles
<i>Earthen Levee</i>								
Encroachments					2.70	0.49		
<i>Supplemental</i>								
2017 USACE Erosion Survey, DRAFT	0.01		0.01	0.03%				
DWR UCIP Field Study					0.02			
DWR UCIP LMA Responsibility								
<i>LMA Totals:</i>	0.01	0.00	0.01	0.03%	2.72	0.49	0.00	0.00
Unit No. 01 Yuba River LB	Overall Unit Rating	Total Unit Miles						
RD0784	A	2.21						
Rated Item	Maintenance Deficiency				Enforcement		Design & System Obsolescence	
	M Miles	U Miles	M + 4U Miles	Threshold %	M Miles	U Miles	M Miles	U Miles
<i>Earthen Levee</i>								
Encroachments					0.12	0.49		
<i>Supplemental</i>								
DWR UCIP Field Study					0.01			
<i>Unit Totals:</i>	0.00	0.00	0.00	0.00%	0.13	0.49	0.00	0.00

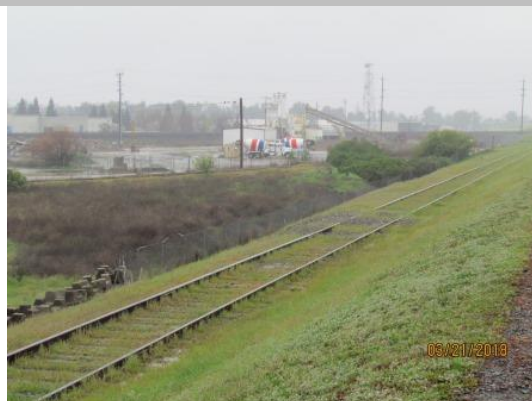
Photo 1 of 2 : FA_2018_RD0784_178_13_20180918_00002.jpg

LM Start	1.00	Rating **	M	Issue No.	13
LM End	1.12	Issue Type +	En	Location *	LS
Category	Earthen Levee			GPS Latitude/Longitude	
				Start	End
Item	Encroachments			39.129475 °	39.129615 °
				-121.569210 °	-121.571371 °
DWR ID	DWR_RD0784_01_f_2012_13				
Comment Code					
FE : Fence					
Inspector Comment					
Fence near the levee toe.

View looking downstream landside of a fence near the levee toe.

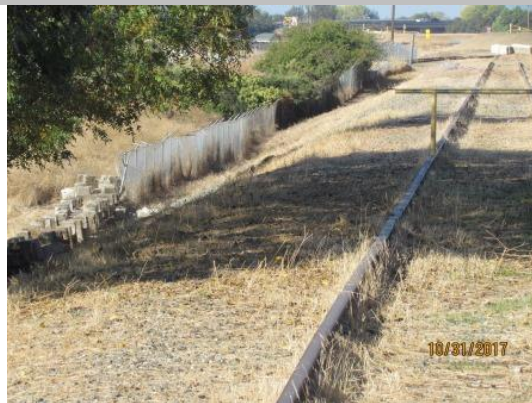
Photo 2 of 2 : FA_2018_RD0784_178_13_20180918_00003.jpg

View looking downstream landside of a fence near the levee toe, Fall 2017.

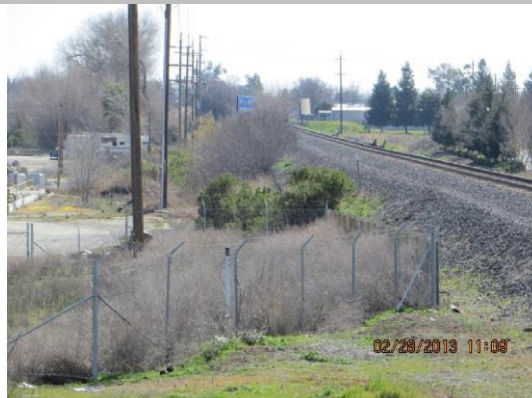
Photo 3 of 3 : UCIP_FA_2018_50677_54400.jpg

Comment Code						
Inspector Comment						
FS_ID:50677 DS_ID:18552 EP_NO: N/A Repair Type: Non-Urgent Crossing Status: Indicator Found UCIP Comments: 11/15/2016 - Crossing is still Non-Urgent due to the possibility that the pipe is unpermitted. The crossing will be downgraded when owner provides permit or CVFPB enforcement resolves the issue. (DWR UCIP - thatch)11/01/2015 - Letter requesting permit or to provide permit sent to owner Century Link, 700 W. Mineral Avenue, Rm D 27.34, Littleton, CO 80120 on 2/18/2014. Pending CVFPB enforcement on utility crossing owner. Requesting DWR inspector to change the status of this issue to "No Action Needed" (P. Meagher - RD784) 02/28/2013 - No permit identified for this crossing. Need to determine if owner has permit. (W.Wylie UCIP Inspector). FIELD_STRUCT_DESC: Fiber optics communications lines of an unknown material and diameter through the levee, at an unknown depth. [Additional Reference(s): DWR Levee Log, 2005]. FS Date: 9/11/2015 9:08:00 AM

Marker on East side of Rail/LS of levee.

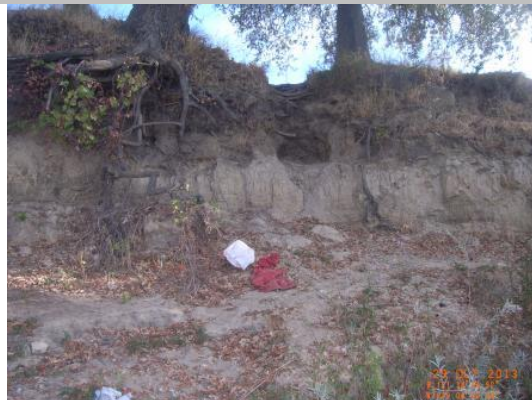
Photo 1 of 1 : FA_2018_RD0784_532_1_20181108_00004.jpg

Comment Code					
Inspector Comment					
2017 Site ID: FHR 17.8 L					
Status: Eroding					
2017 Field Notes: Large sandbar on opposite bank, thalweg moving closer to levee.					
Site History: 2003 - Bank is near vertical. Identified as a Potentially Critical site. 2004 - Eddy flow off downstream end of Modesto formation eroding the fluvial sediments. 2005 - Some new slumping. Actively eroding but berm width is greater than 50 ft. 2006 - Downgraded to regular erosion site. Still actively eroding. Large old rotational failures in high bank on the downstream end. 2008 - Removed from inventory due to wide berm width does not meet criteria for an erosion site. 2010 - Added back to the inventory after 10 ft of bank erosion in the winter 2009 storm. Steep vertical face. 2011 - Bank has retreated an additional 2.5 ft from last year. New tree popouts and erosion throughout the site. 2012 - Site continues to worsen with new tree popouts and many sections of new erosion.

USACE 2013 Photo #1

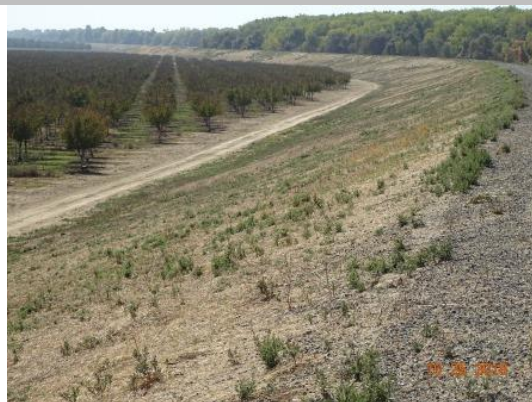
Photo 1 of 1 : FA_2018_RD0784_532_2_20181106_00002.jpg

LM Start	9.11	Rating **	A	Issue No.	2
LM End	12.79	Issue Type +	Ma	Location *	LS
Category	Earthen Levee			GPS Latitude/Longitude	
				Start	End
Item	Vegetation			39.007954 °	38.955601 °
				-121.578178 °	-121.574977 °
DWR ID	DWR_RD0784_02B_f_2018_2				
Comment Code					
V1 : Control annual grass and weeds on the levee slopes and easements.					
Inspector Comment					
The annual vegetation is well maintained, Fall 2018.

View looking downstream landside of the well maintained annual vegetation, Fall 2018.

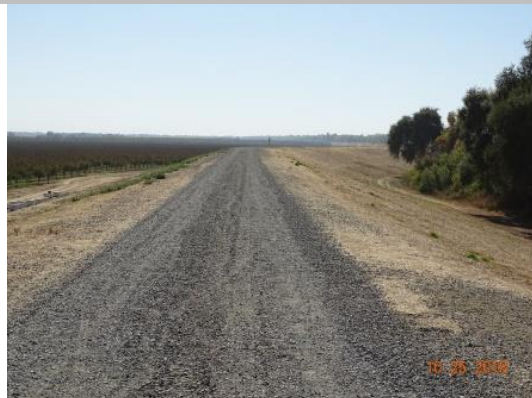
Photo 1 of 1 : FA_2018_RD0784_532_3_20181106_00003.jpg

View looking downstream waterside of the well maintained annual vegetation, Fall 2018.

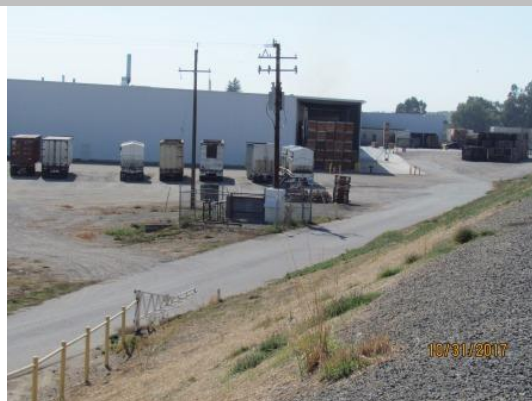
Photo 1 of 1 : FA_2018_RD0784_532_6_20180918_00001.jpg

LM Start	9.21	Rating **	M	Issue No.	6
LM End	9.31	Issue Type +	En	Location *	LS
Category	Earthen Levee			GPS Latitude/Longitude	
				Start	End
Item	Encroachments			39.006523 °	39.005235 °
				-121.577843 °	-121.578286 °
DWR ID	DWR_RD0784_02_f_2012_6				
Comment Code					
MA : Material					
Inspector Comment					
Un-permitted paving at levee toe.

View looking downstream on the land side of un-permitted paving.

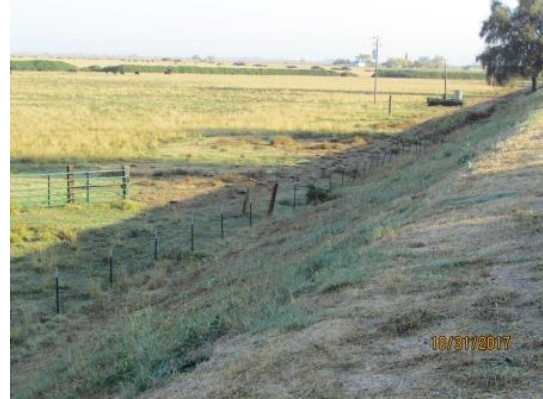
Photo 1 of 1 : FA_2018_RD0784_534_7_20180918_00001.jpg

View looking upstream landside of a fence that is at the levee toe.

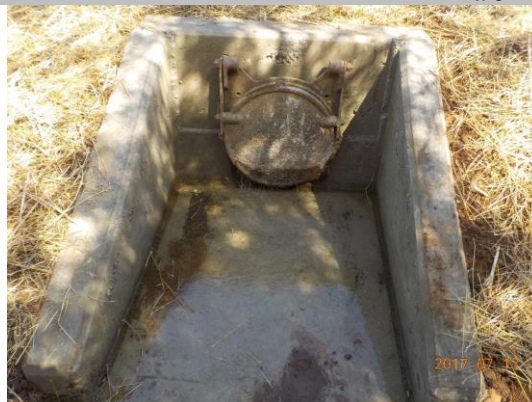
Photo 2 of 3 : UCIP_FA_2018_53072_77115.jpg

Concrete collar completed around the waterside exterior flap gate section.

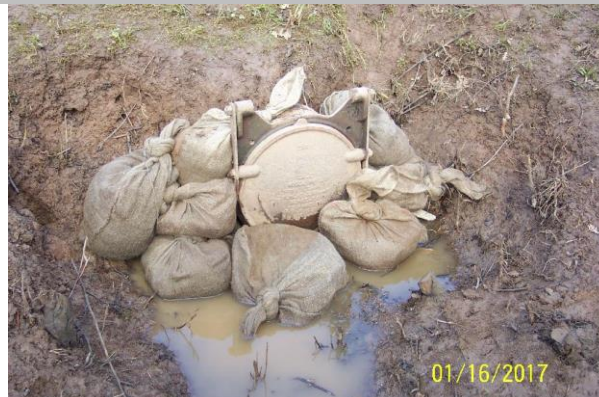
Photo 3 of 3 : UCIP_FA_2018_53072_76618.jpg

Sandbags temporarily placed in front of flapgate.

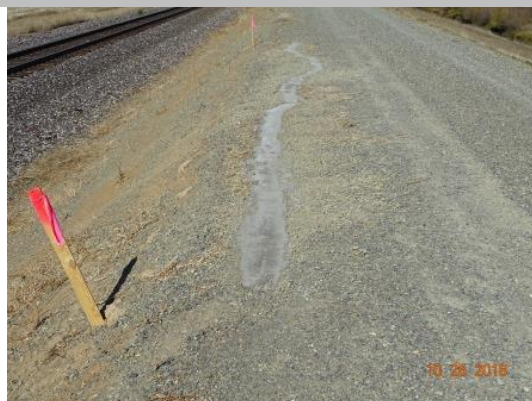
Photo 1 of 1 : FA_2018_RD0784_181_4_20181106_00006.jpg

LM Start	1.09	Rating **	A/W	Issue No.	4
LM End	1.09	Issue Type +	Ob	Location *	CR
Category	Earthen Levee			GPS Latitude/Longitude	
				Start	End
Item	Cracking			38.990383 °	38.990383 °
				-121.538051 °	-121.538051 °
DWR ID	DWR_RD0784_04_f_2018_4				
Comment Code					
CR1 : Monitor and have inspected by geotechnical engineer.					
Inspector Comment					
Lineal cracking on the crown has been repaired but needs to be monitored through the rainy season, Fall 2018.

View looking upstream on the crown of lineal cracking that has been repaired but needs to be monitored through the rainy season, Fall 2018.

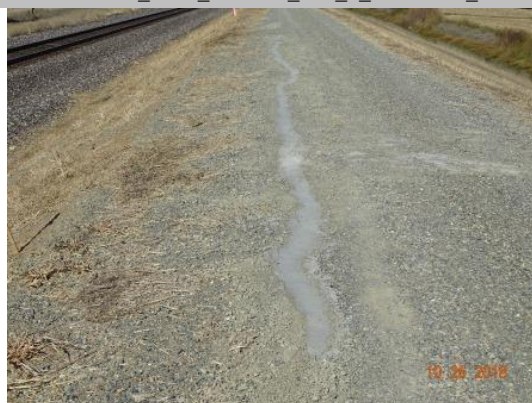
Photo 1 of 1 : FA_2018_RD0784_181_5_20181106_00007.jpg

LM Start	1.61	Rating **	A/W	Issue No.	5
LM End	1.61	Issue Type +	Ob	Location *	CR
Category	Earthen Levee			GPS Latitude/Longitude	
				Start	End
Item	Cracking			38.997839 °	38.997839 °
				-121.539477 °	-121.539477 °
DWR ID	DWR_RD0784_04_f_2018_5				
Comment Code					
CR1 : Monitor and have inspected by geotechnical engineer.					
Inspector Comment					
Lineal cracking on the crown has been repaired but needs to be monitored through the rainy season, Fall 2018.

View looking upstream on the crown of lineal cracking that has been repaired but needs to be monitored through the rainy season, Fall 2018.

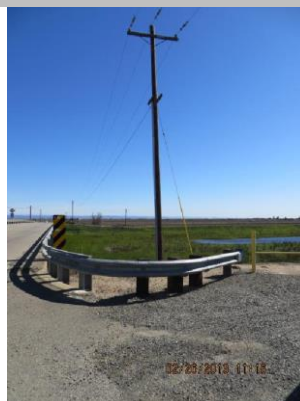
Photo 1 of 3 : UCIP_FA_2018_46600_54244.jpg

LM Start	3.59	Rating **	M	Issue No.	6	
LM End	3.59	Issue Type +	En	Location *		
Category	Supplemental			GPS Latitude/Longitude		
				Start	End	
Item	DWR UCIP Field Study			39.026347 °	39.026347 °	
				-121.542343 °	-121.542343 °	
DWR ID	22686					
Comment Code						
Inspector Comment						
FS_ID:46600						
DS_ID:22686						
EP_NO: N/A						
Repair Type: Non-Urgent						
Crossing Status: Found						
UCIP Comments: 02/26/2013 No permit identified for crossing. (W. Wylie - DWR UCIP)						
FIELD_STRUCT_DESC: Communications cable of an unknown material and diameter through the levee, at an unknown depth, on the downstream side of the bridge. [Additional Reference(s): USACE Sacramento O&M Manual 145, August 1955, (Station 132+40), listed as an 18-inch pipe].						
FS Date: 9/11/2015 9:25:57 AM

Communication line at base of JP on WS slope.

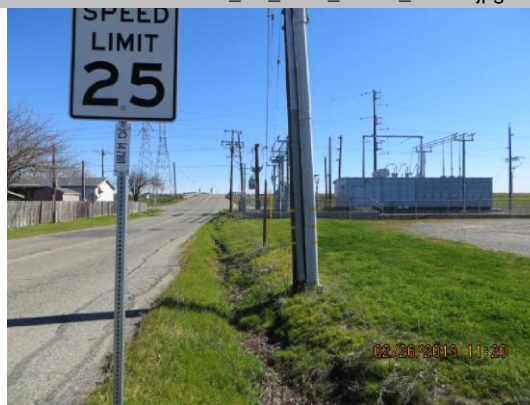
Photo 2 of 3 : UCIP_FA_2018_46600_54243.jpg

Communication line runs on south side of Plumas Arboga Road to JP approximately 400-feet West of levee crown.

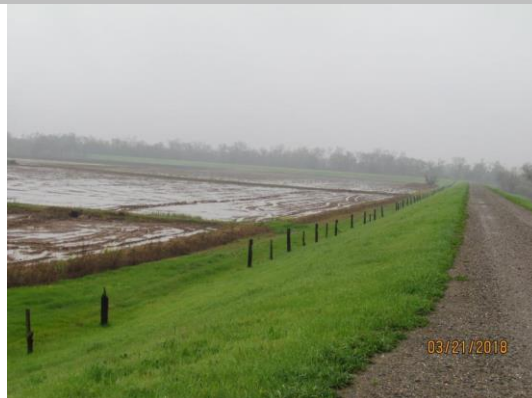
Photo 1 of 1 : FA_2018_RD0784_182_16_20180918_00006.jpg

View looking downstream landside of old fence post that need to be removed, Spring 2018.

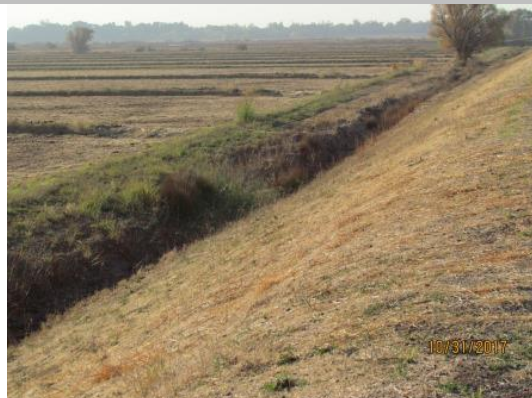
Photo 1 of 2 : FA_2018_RD0784_182_10_20180918_00004.jpg

View of landside looking downstream at the ditch that is along the levee toe. Fall 2017.

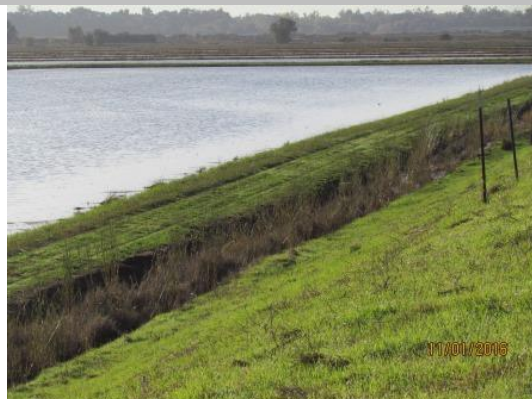
Photo 2 of 2 : FA_2018_RD0784_182_10_20180918_00005.jpg

View of landside looking downstream at the ditch that is along the levee toe. Fall 2016.

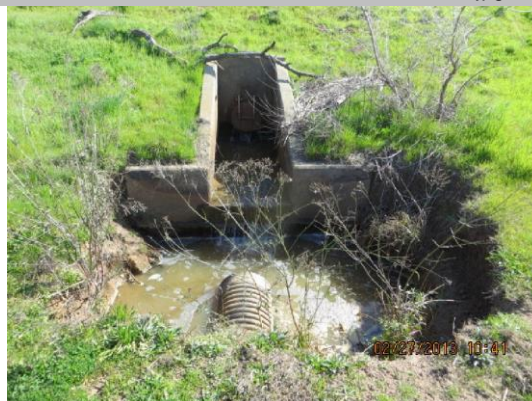
Photo 2 of 3 : UCIP_FA_2018_51707_54253.jpg

Concrete U-shaped headwall on WS toe with Flap gate showing erosion at outlet.

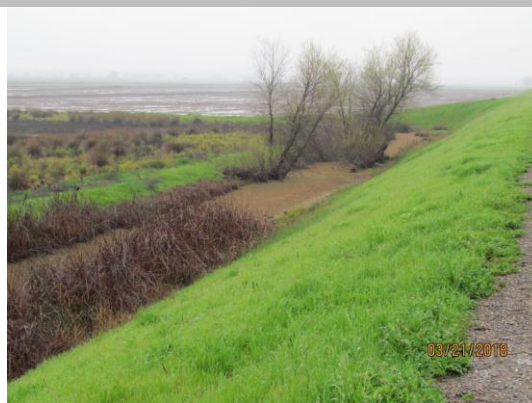
Photo 1 of 1 : FA_2018_RD0784_182_9_20180918_00003.jpg

View of landside looking downstream at the ditch that is along the levee toe.

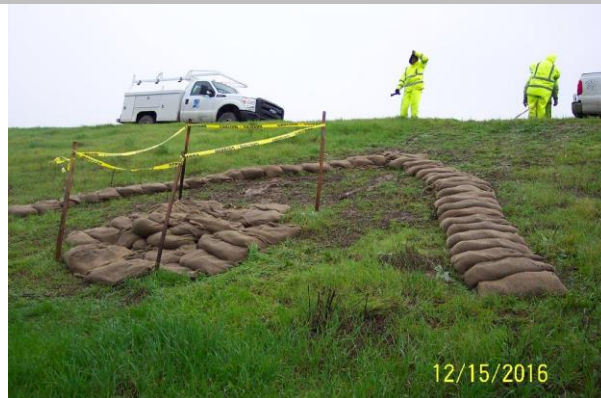
Photo 2 of 3 : UCIP_FA_2018_53070_76309.jpg

WS view: Sink hole filled in with sandbags and "V" shaped diversion dam built to help divert rainwater.

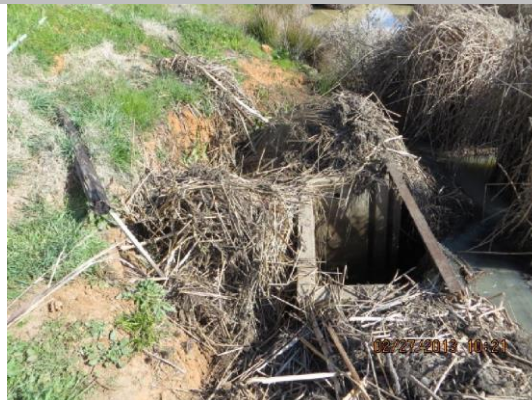
Photo 3 of 3 : UCIP_FA_2018_53070_54254.jpg

Erosion and debris from Beaver activity.

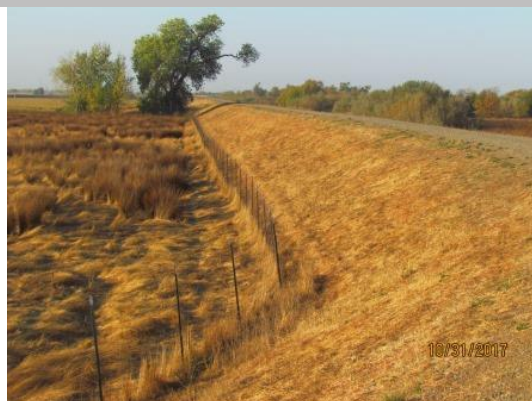
Photo 1 of 1 : FA_2018_RD0784_182_5_20180918_00001.jpg

View of fence along the landside toe looking downstream.

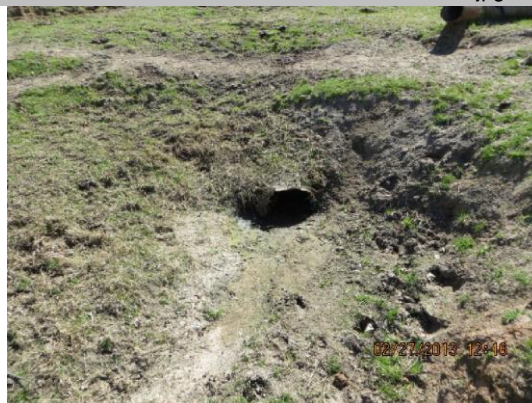
Photo 2 of 3 : UCIP_FA_2018_51716_54268.jpg

Partially clogged inlet pipe at LS toe.

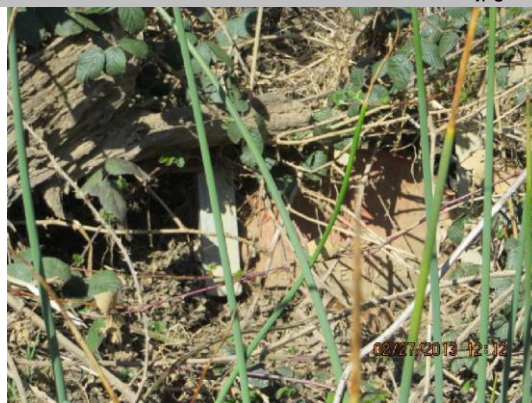
Photo 3 of 3 : UCIP_FA_2018_51716_54265.jpg

Flap gate blocked by vegetation at WS.
